Attachments to Appendix B

Attachment B-1

Photographic Documentation of Site Reconnaissance (2-6 March 1998)

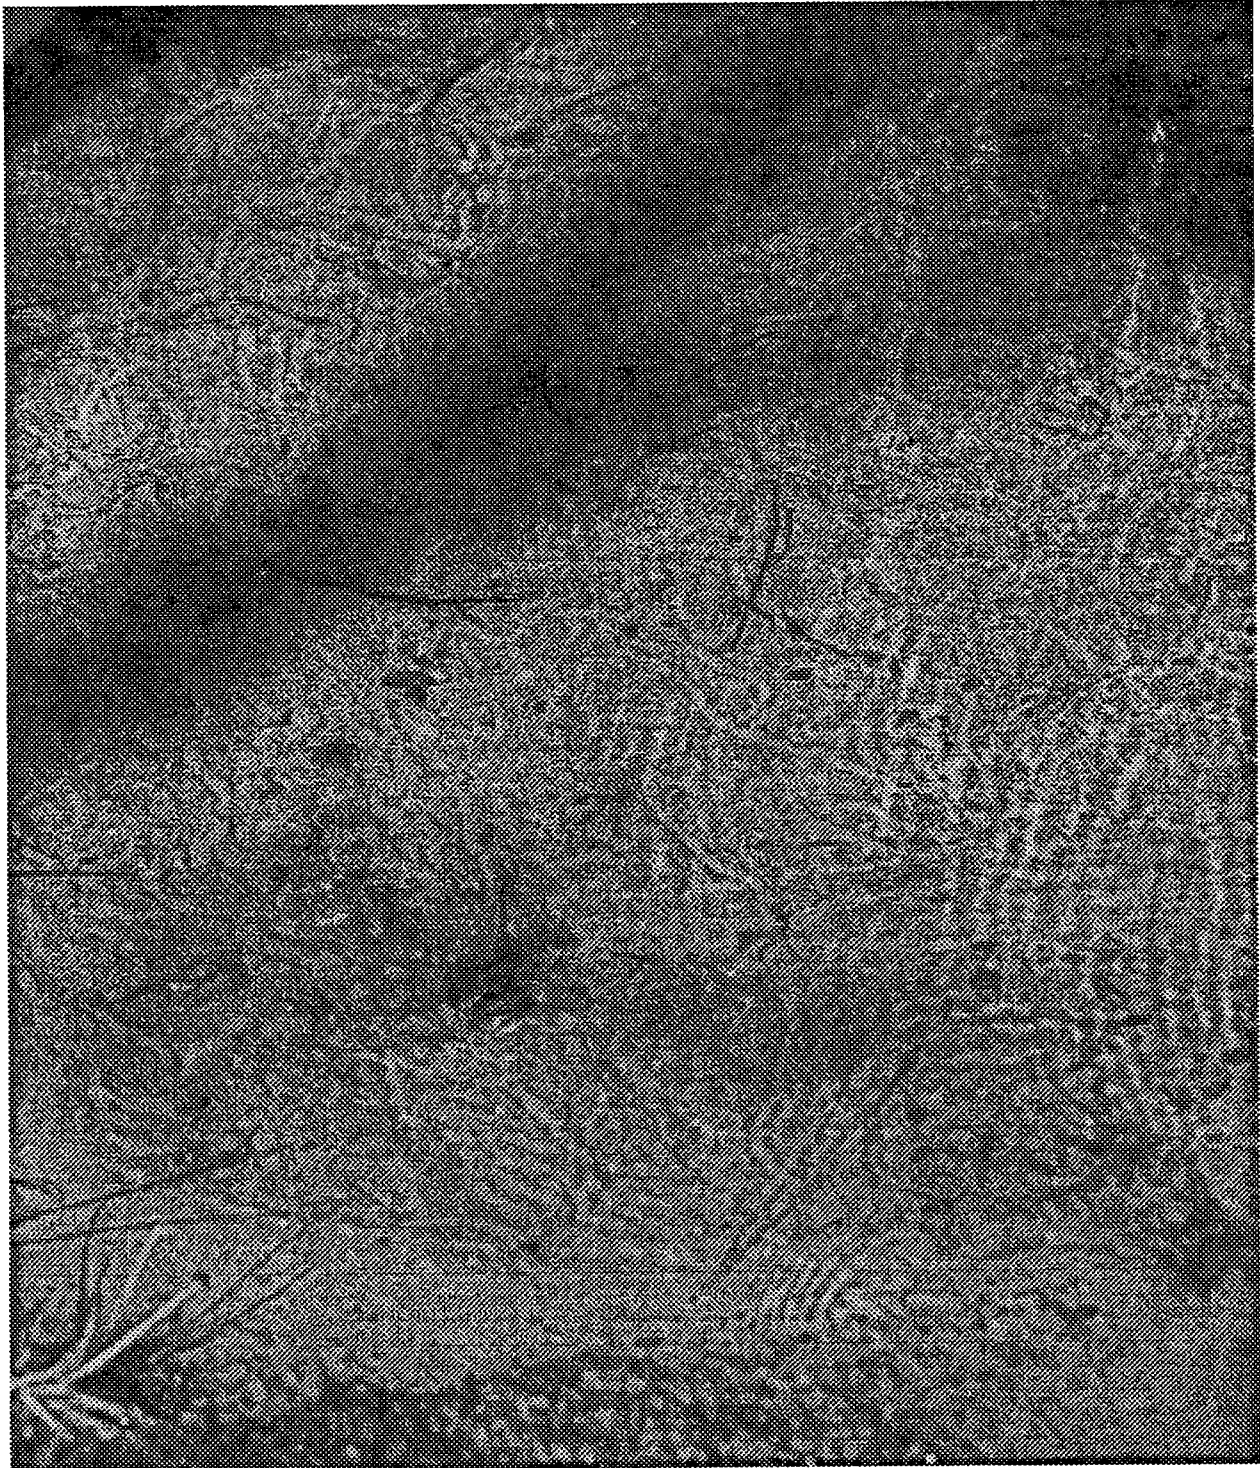
Photo A12 [3/3/98 - 11:15]

Former DPDO Area Building 1800 and current Autocraft Area [CERFA Parcel Map: 18,28-29]
Area contains sites 100(7), 20(7), and 47(7), and is nestled between the fork of South Branch Creek and an unnamed tributary to same; photo is directly into stream.

The view is typical of the condition of this reach of South Branch creek. It is an example of a large *Elimnia* (freshwater snail genus) population in this reach of South Branch creek.

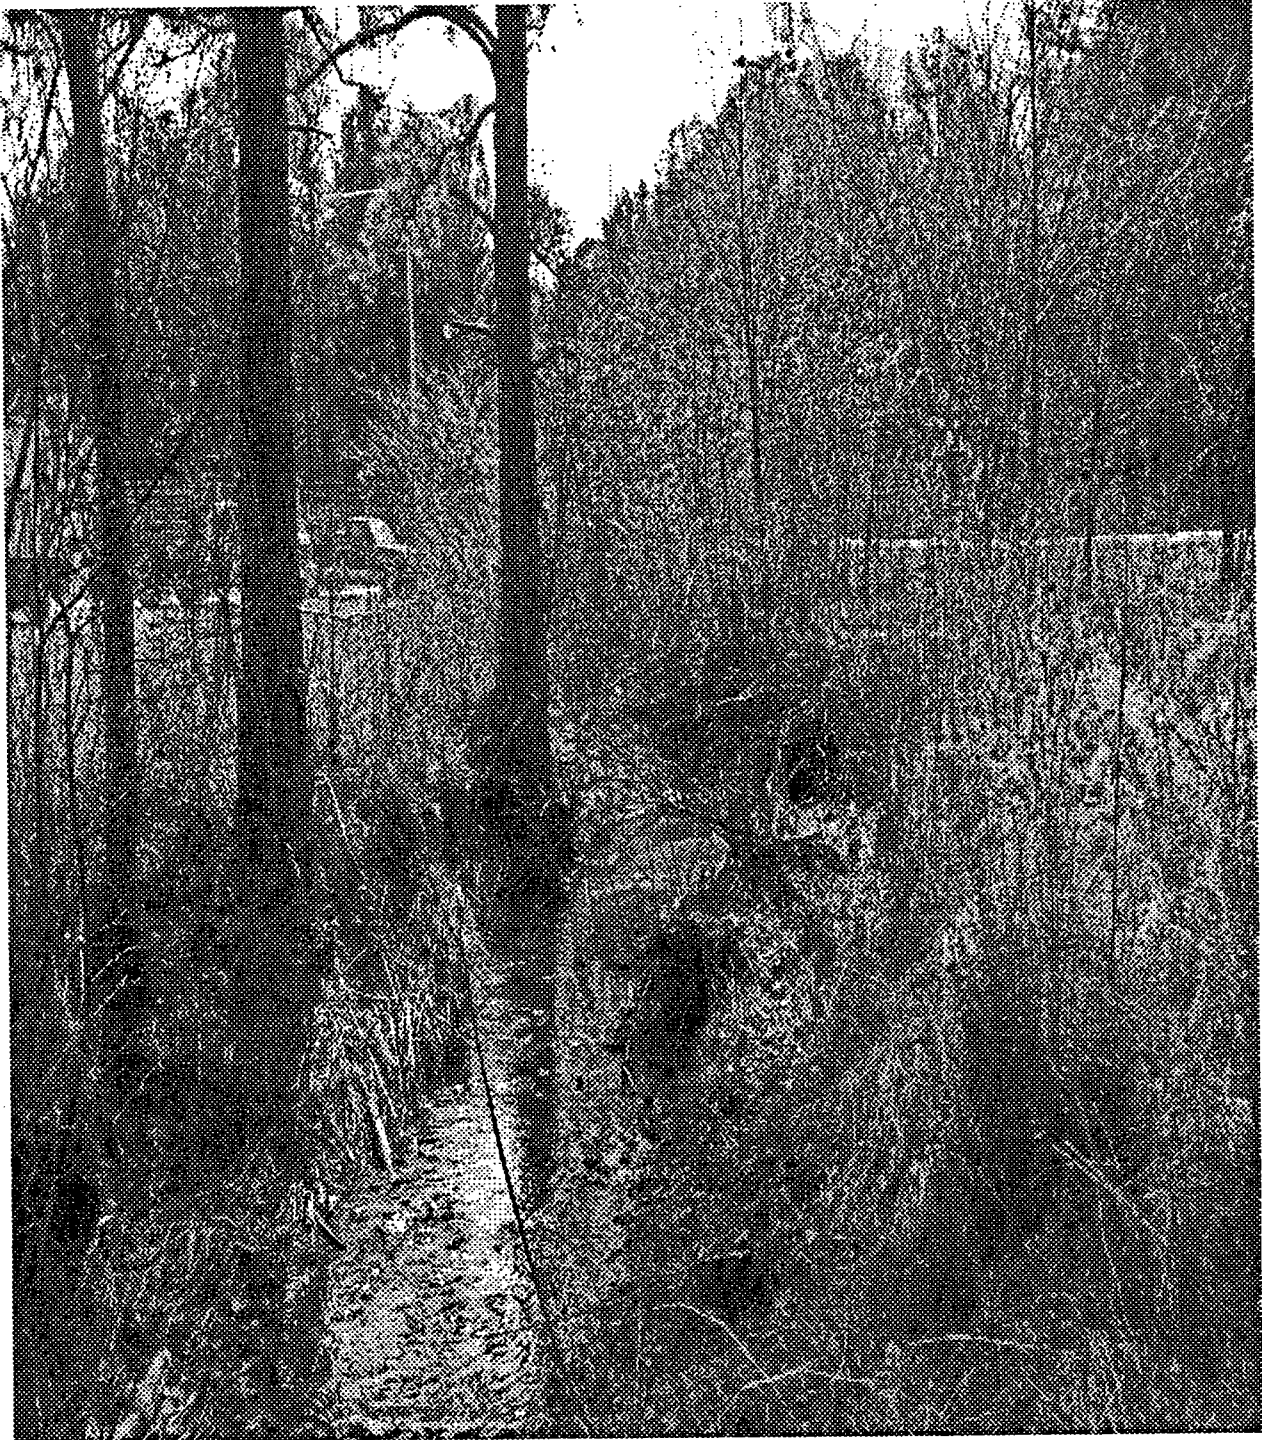
Photo A13 [3/3/98 - 11:24]

Former DPDO Area Building 1800 and current Autocraft Area [CERFA Parcel Map: 18,28-29]
Area contains sites 100(7), 20(7), and 47(7), and is nestled between the fork of South Branch Creek and an unnamed tributary to same; from north end of facility; photo faces S direction along unnamed tributary.

The view looks toward drainage pipes under the adjacent street, and draining runoff from Autocraft Area and from across the street. Habitat along the tributary is brush immediately next to the creek, and open grass farther away from the creek. Farther downstream along the tributary (behind the viewer) is its confluence with South Branch Creek.

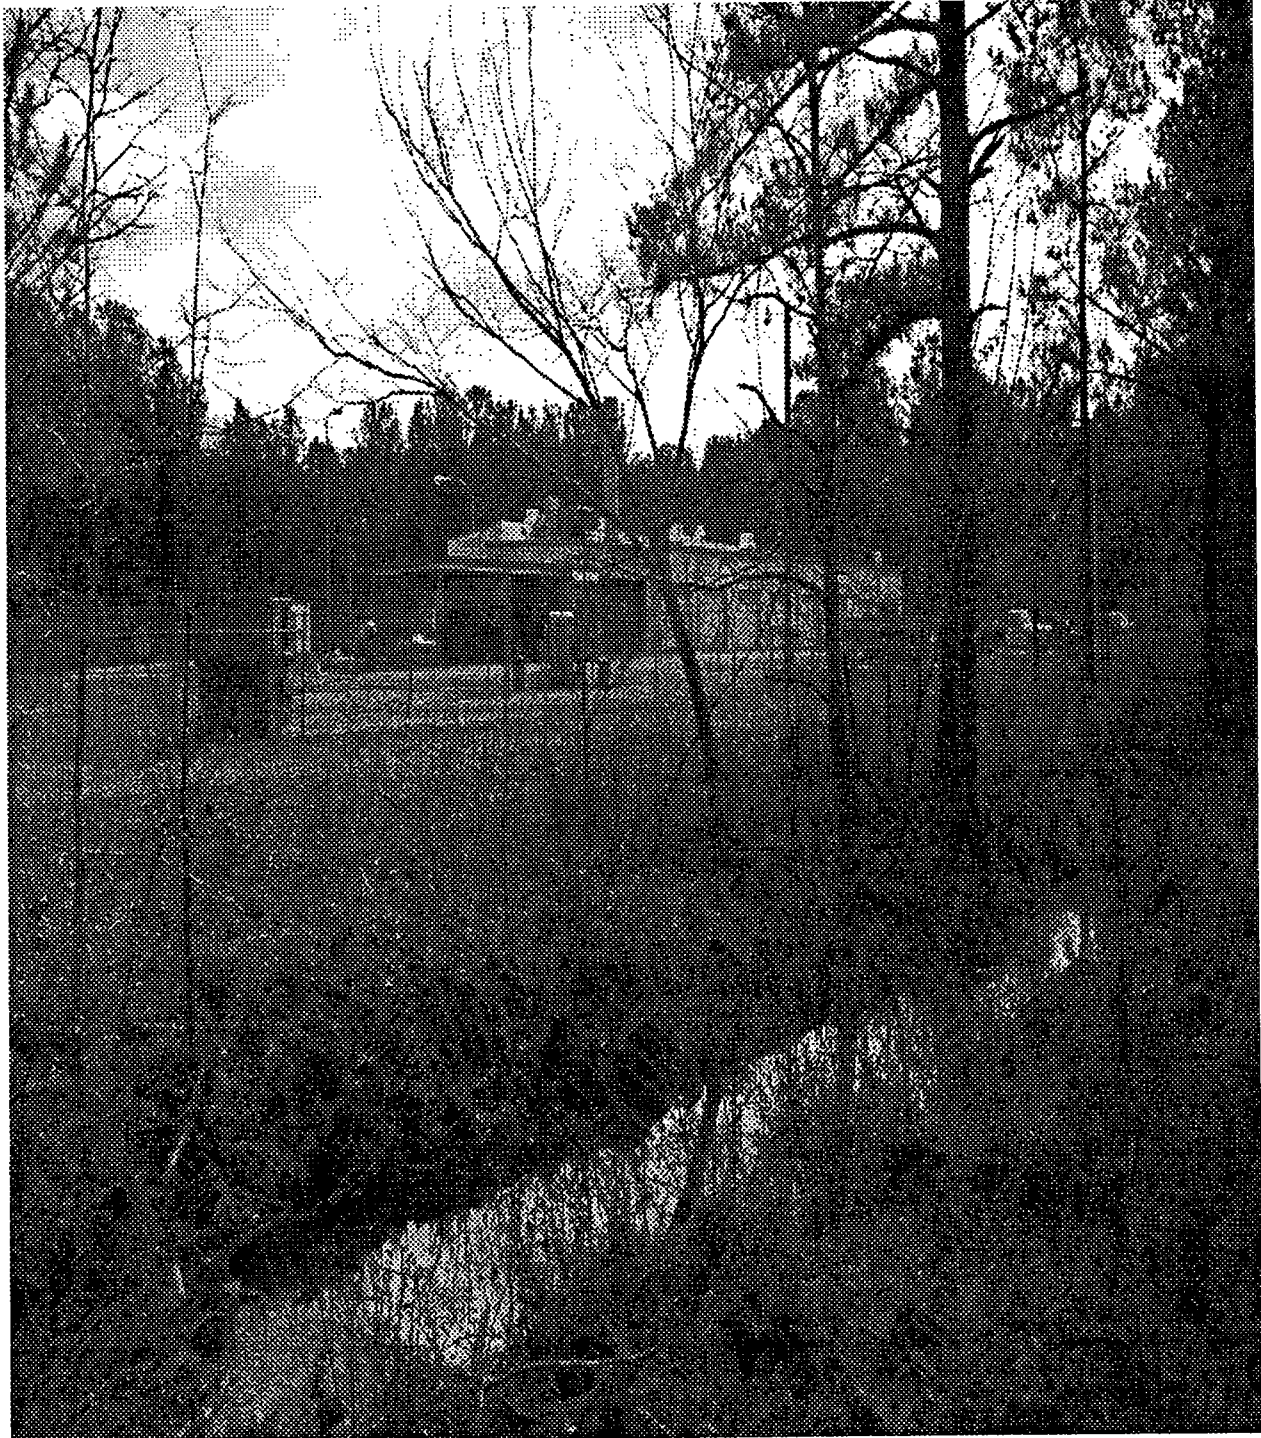
Photo A14 [3/3/98 - 11:26]

Former DPDO Area Building 1800 and current Autocraft Area [CERFA Parcel Map: 18,28-29]
Area contains sites 100(7), 20(7), and 47(7), and is nestled between the fork of South Branch Creek and an unnamed tributary to same; from farther down stream, facing S direction Autocraft Area

Similar view as in Photo A13, farther downstream. At the lower left corner of the photo (just out of view), the tributary has been channelized by metal conduit, and is covered with soil and grass for approximately 30-40 yards. The opposite end of this conduit empties into the unaltered creek (see Photo A15).

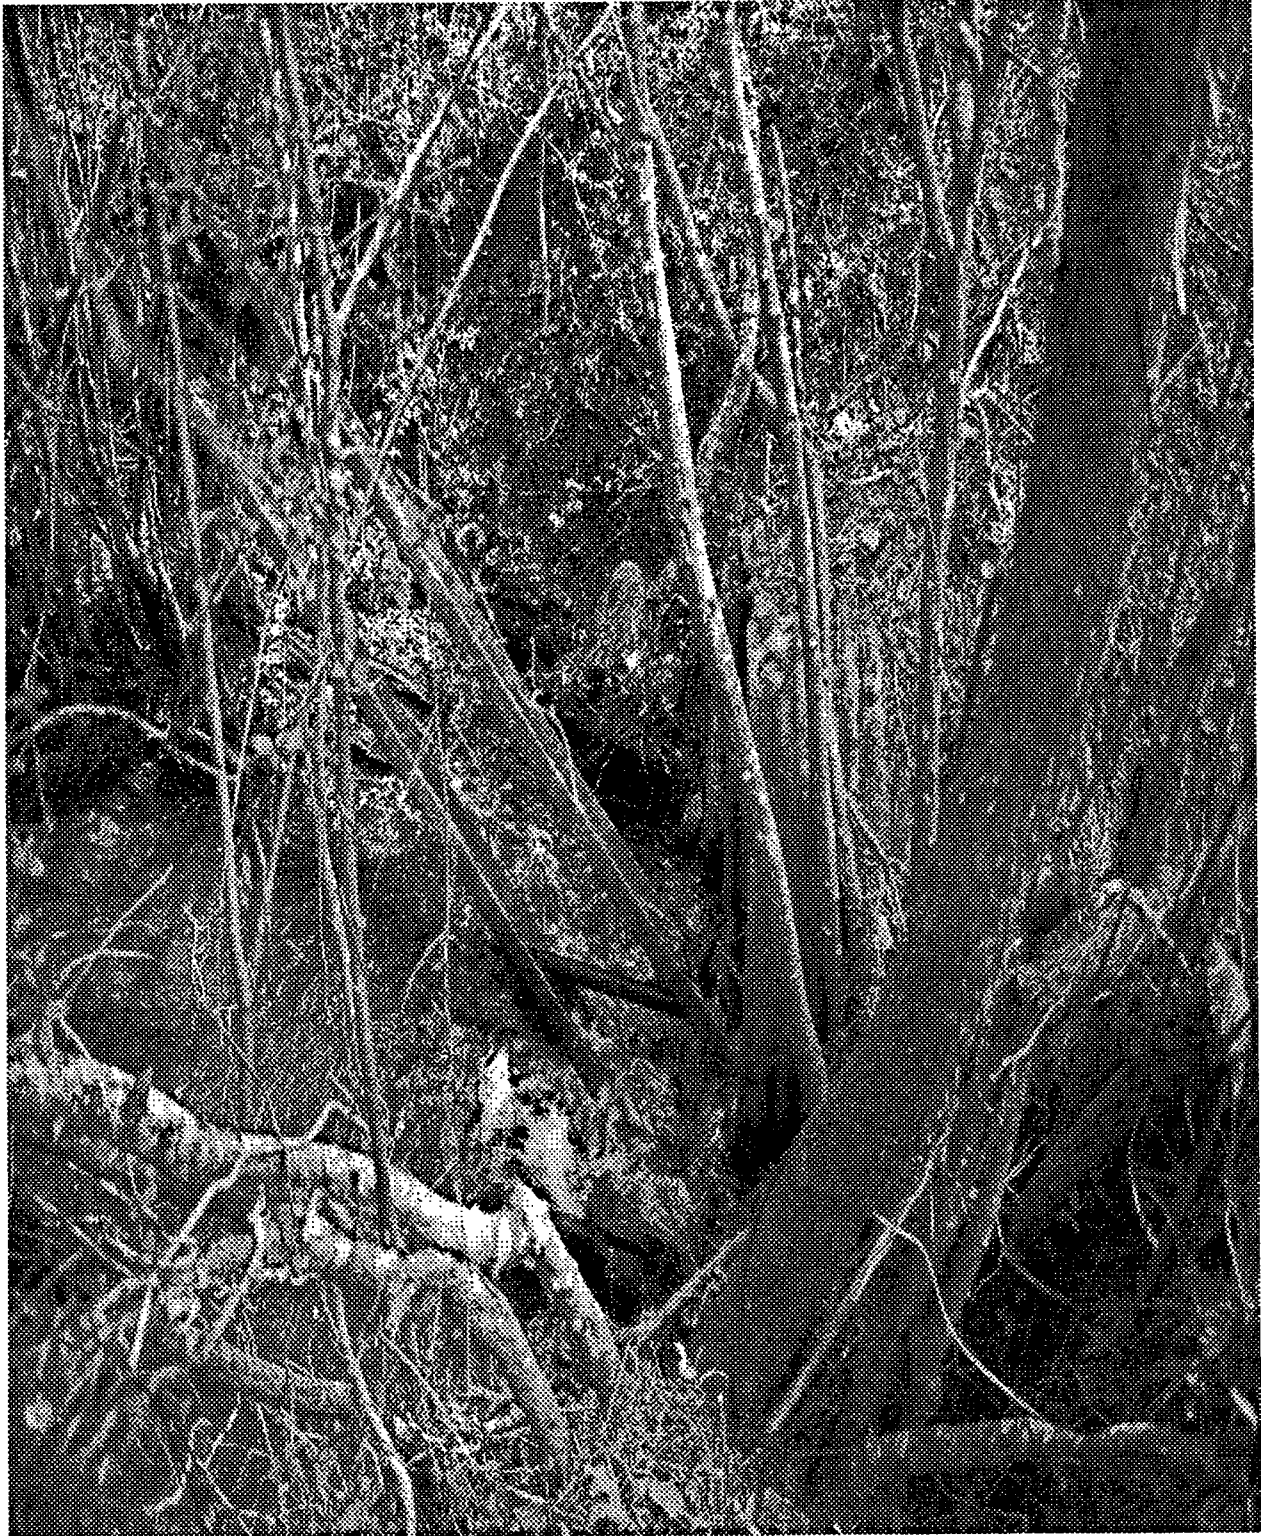
Photo A15 [3/3/98 - 11:28]

Former DPDO Area Building 1800 and current Autocraft Area [CERFA Parcel Map: 18,28-29]

Area contains sites 100(7), 20(7), and 47(7), and is nestled between the fork of South Branch Creek and an unnamed tributary to same; further downstream of unnamed tributary at its re-emergence through metal conduit.

The creek's substrate immediately downstream of the conduit outlet is fine sediment with gravel/sand interspersed.

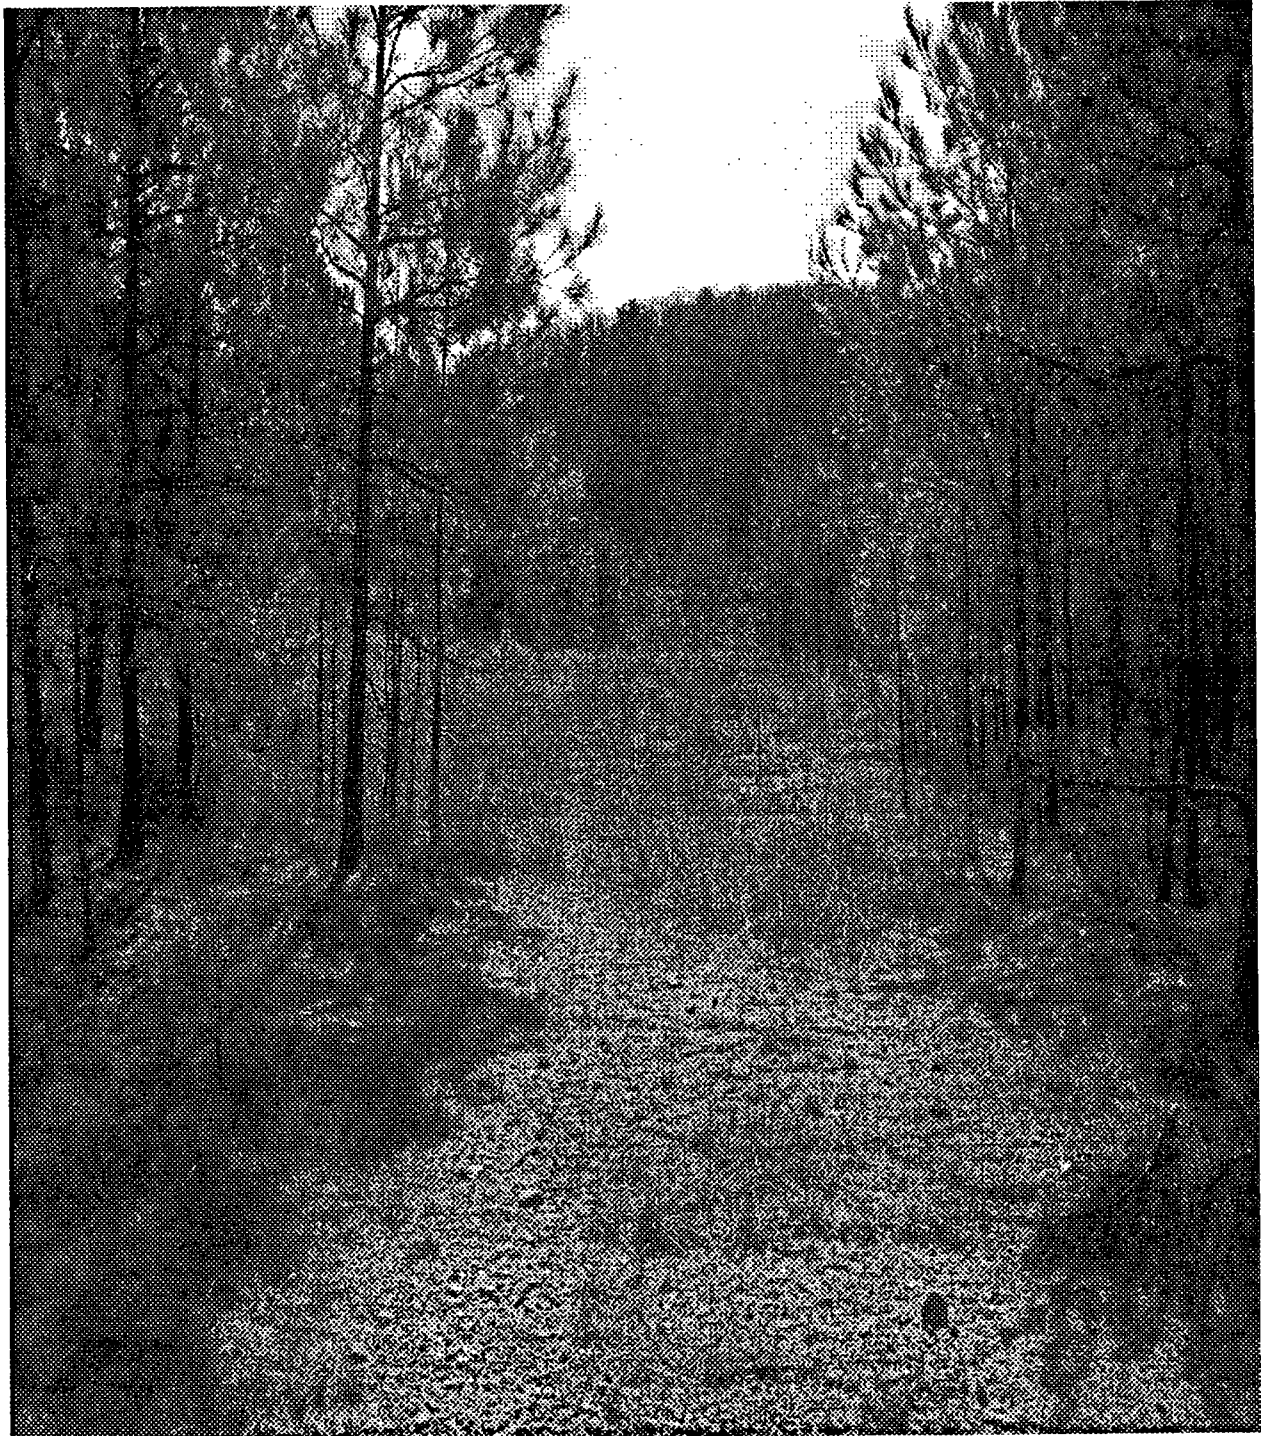
Photo A16 [3/3/98 - 11:34]

Sandel Flame Range [CERFA Parcel Map: 18,27]

Area contains Site 97(7), the flame-thrower training area, lies between hills to the S (shown in photo background) and a large forested area immediately to the N; photo faces SE direction into the open strip of land of site 97(7).

The immediate site is poorly vegetated by short, sparse clumps of dried grasses. Site is surrounded by thick forest (primarily coniferous) with moderate to thick understory. No aquatic habitat was noted at any point within, or on the periphery of, the site. At several locations, the ground showed signs of having been burned and scorched by flame.

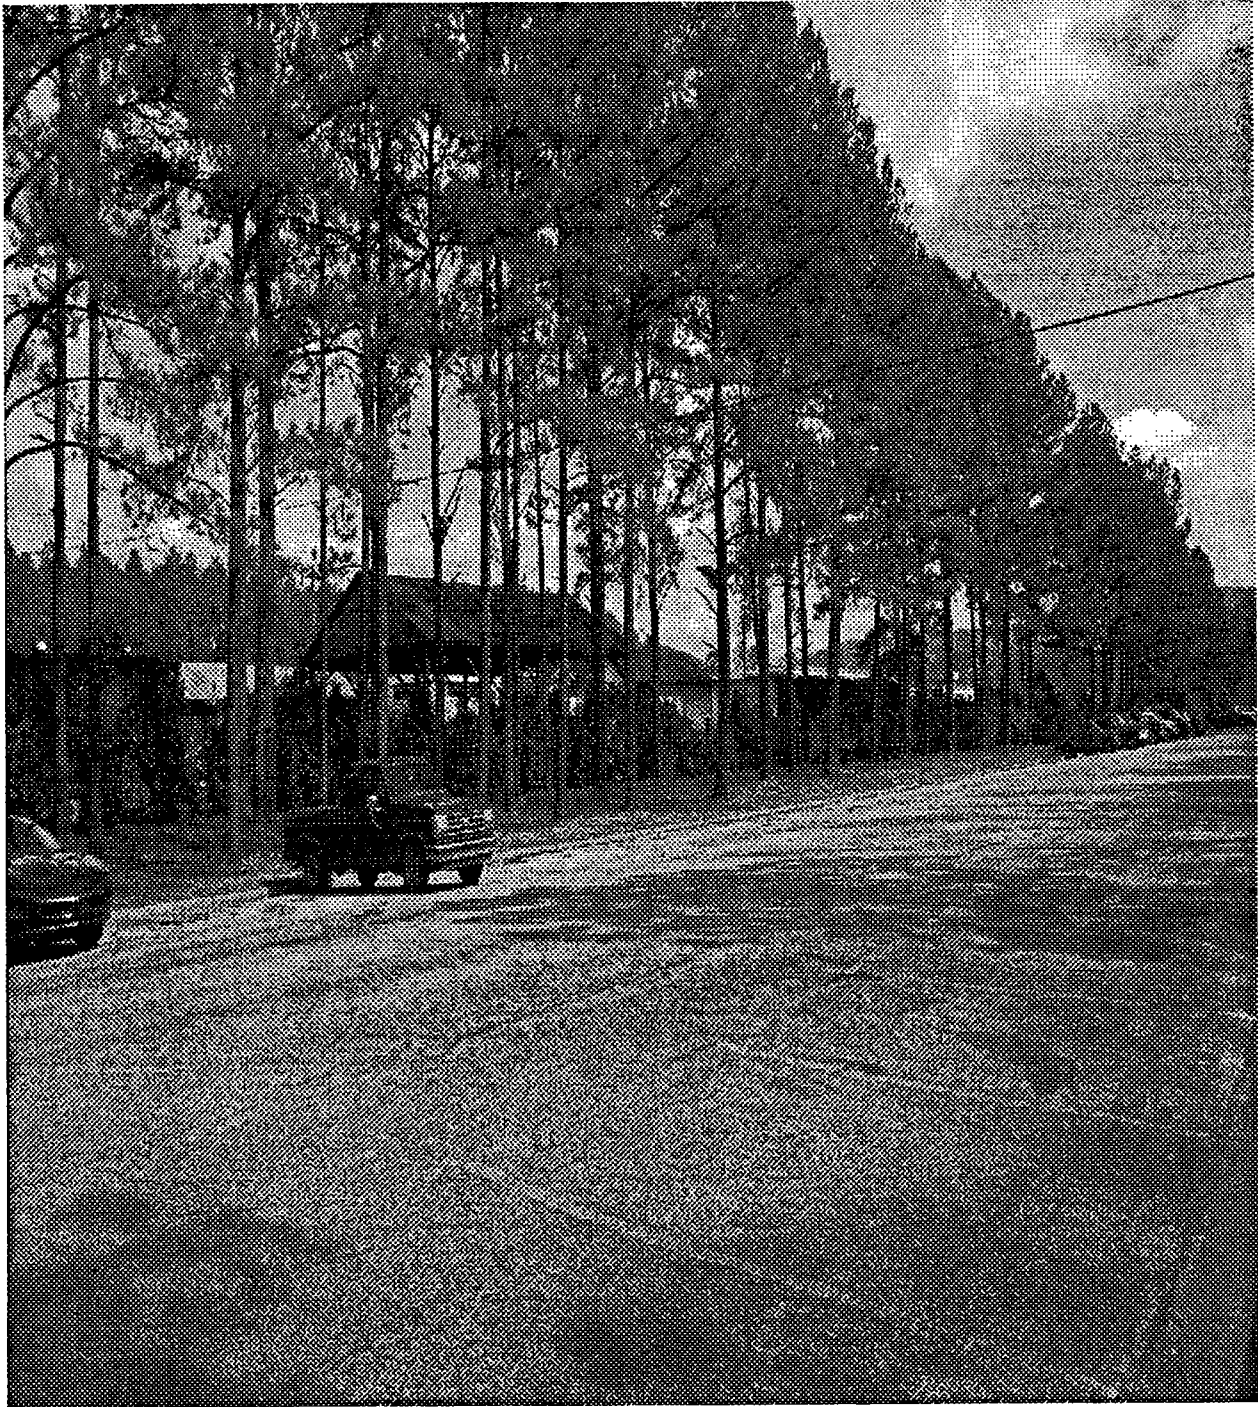
Photo A17 [3/3/98 - 1:00]

Directorate of Engineering and Housing (DEH) compound [CERFA Parcel Map: 17,34-35]

Area consists of Site 64(7) adjacent to N bank of Cane Creek, and contains site 1(7); photo faces NE direction; view is outside southern fence (parking lot).

The view looks over a large, paved area south of the DEH area. The lot separates DEH and Cane Creek for the entire length of the compound. Between the paved lot and Cane Creek (just out of view to the right) is a narrow strip of unaltered land with sparse vegetation and coniferous trees. This reach of Cane Creek is highly channelized and lined by rock/concrete walls. This location is directly across Cane Creek from the GSA Area (see Photo A3).

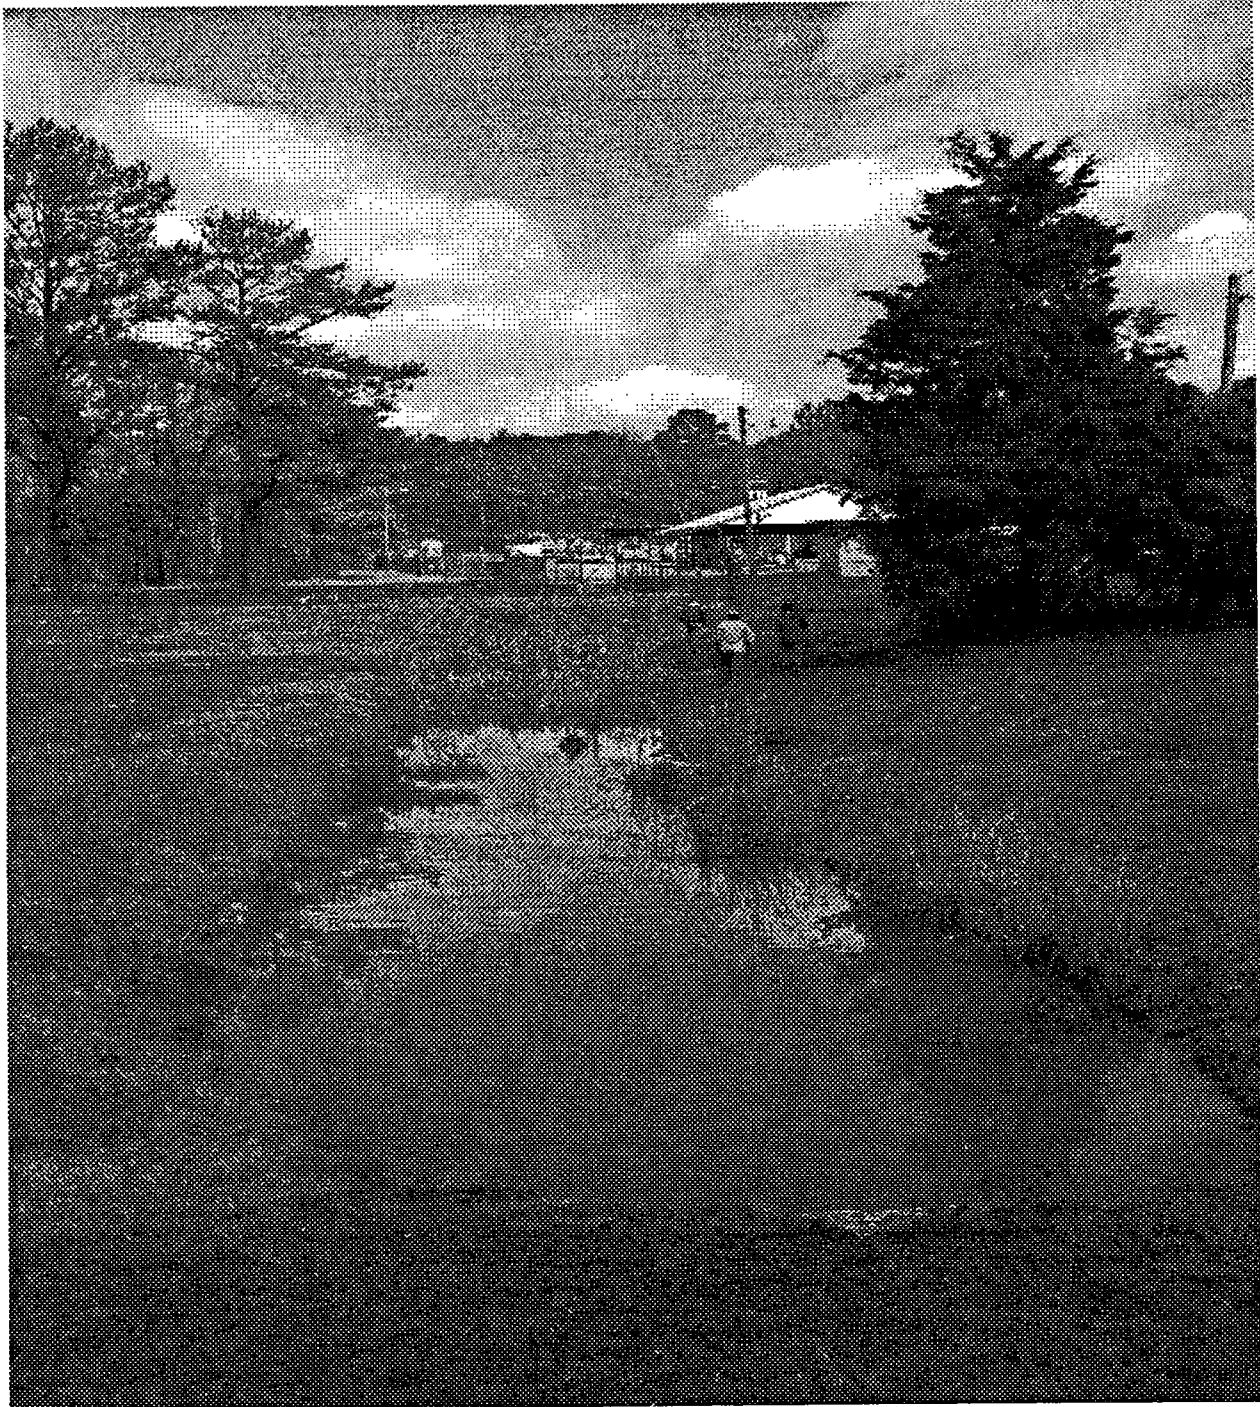
Photo A18 [3/3/98 - 1:05]

Directorate of Engineering and Housing (DEH) compound [CERFA Parcel Map: 17,34-35]

Area consists of Site 64(7) adjacent to N bank of Cane Creek, and contains site 1(7); photo faces NE direction along the W fence of DEH overlooking standing water pond.

This view is typical of the terrestrial habitat surrounding the DEH compound to the W, N, and E. The pond in view is a unique feature; it drains to the S (toward the viewer) toward Cane Creek (see Photo A19), but does not drain completely. A wetland-type area has developed at the northern end of this water pond (in background, adjacent to pedestrians in view; also see Photo A19).

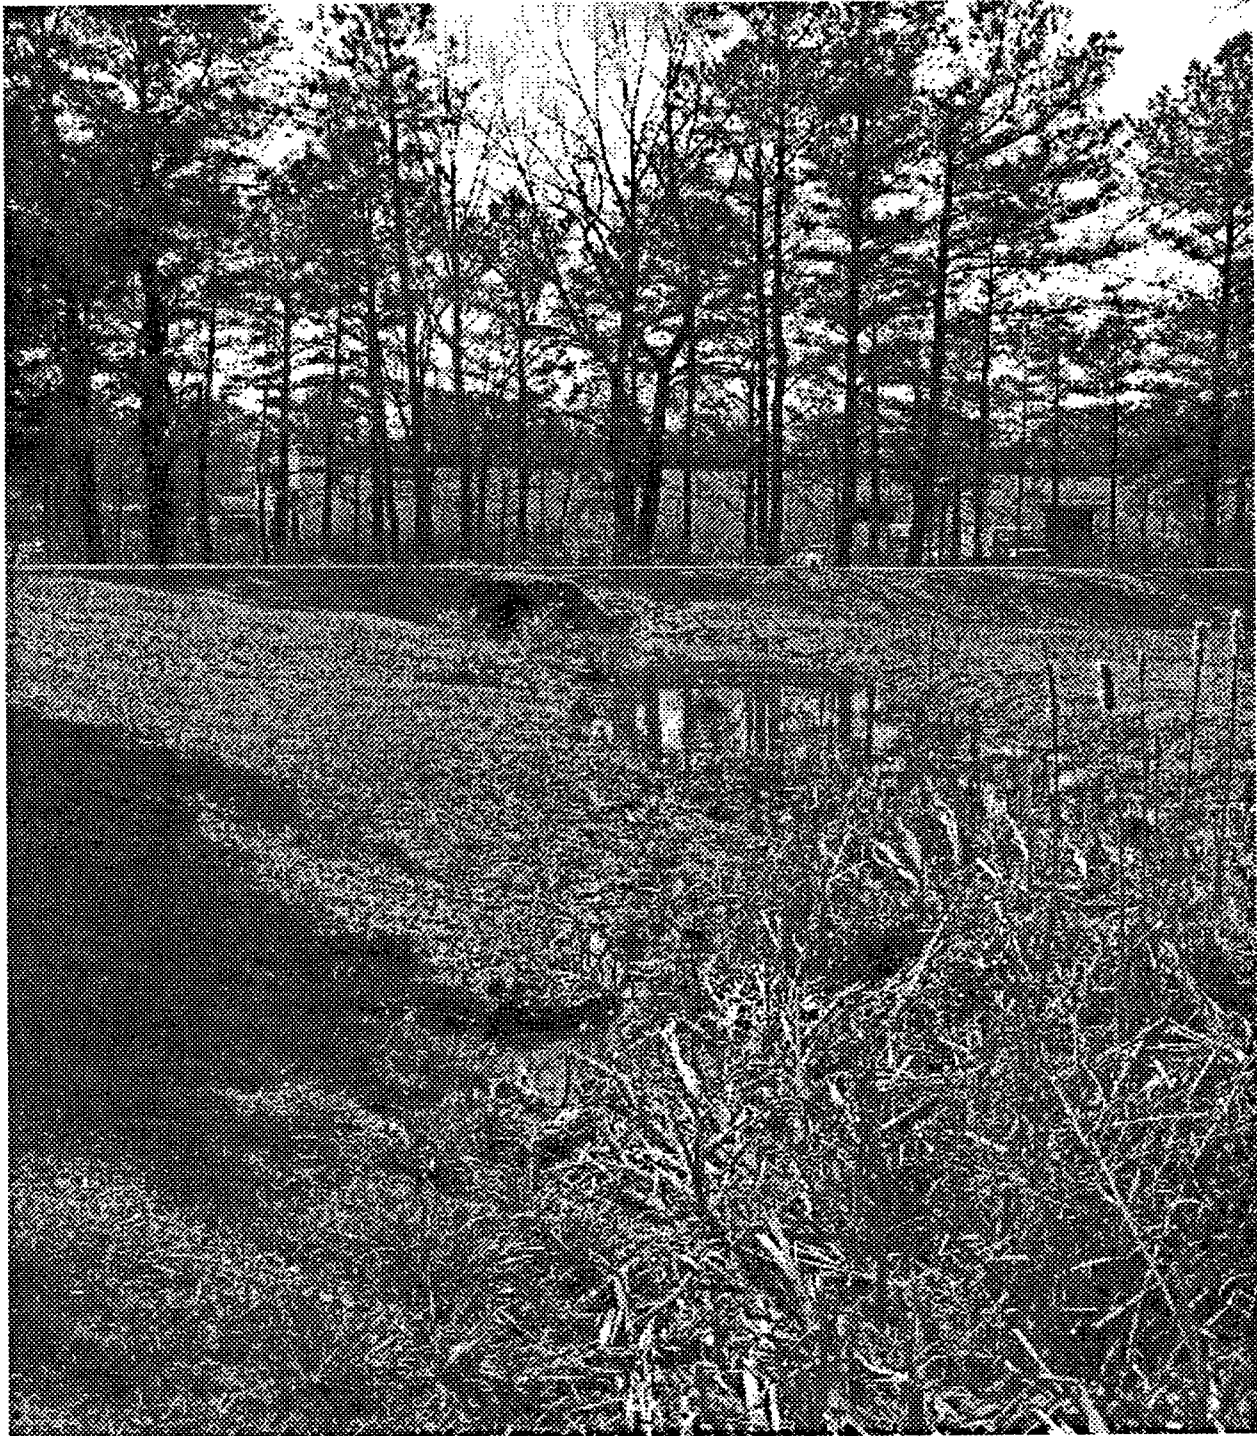
Photo A19 [3/3/98 - 1:10]

Directorate of Engineering and Housing (DEH) compound [CERFA Parcel Map: 17,34-35]

Area consists of Site 64(7) adjacent to N bank of Cane Creek, and contains site 1(7); photo faces SW direction, parallel to the W fence of the DEH compound (just out of view to the left).

The view is looking at the wetland-type area at the northern end of the standing pond (see Photo A18). The stormwater conduits in the shadowed area at the southern end of the pond lead to Cane Creek (behind bridge). White building behind trees in the background is part of the GSA area (see Photo A3).

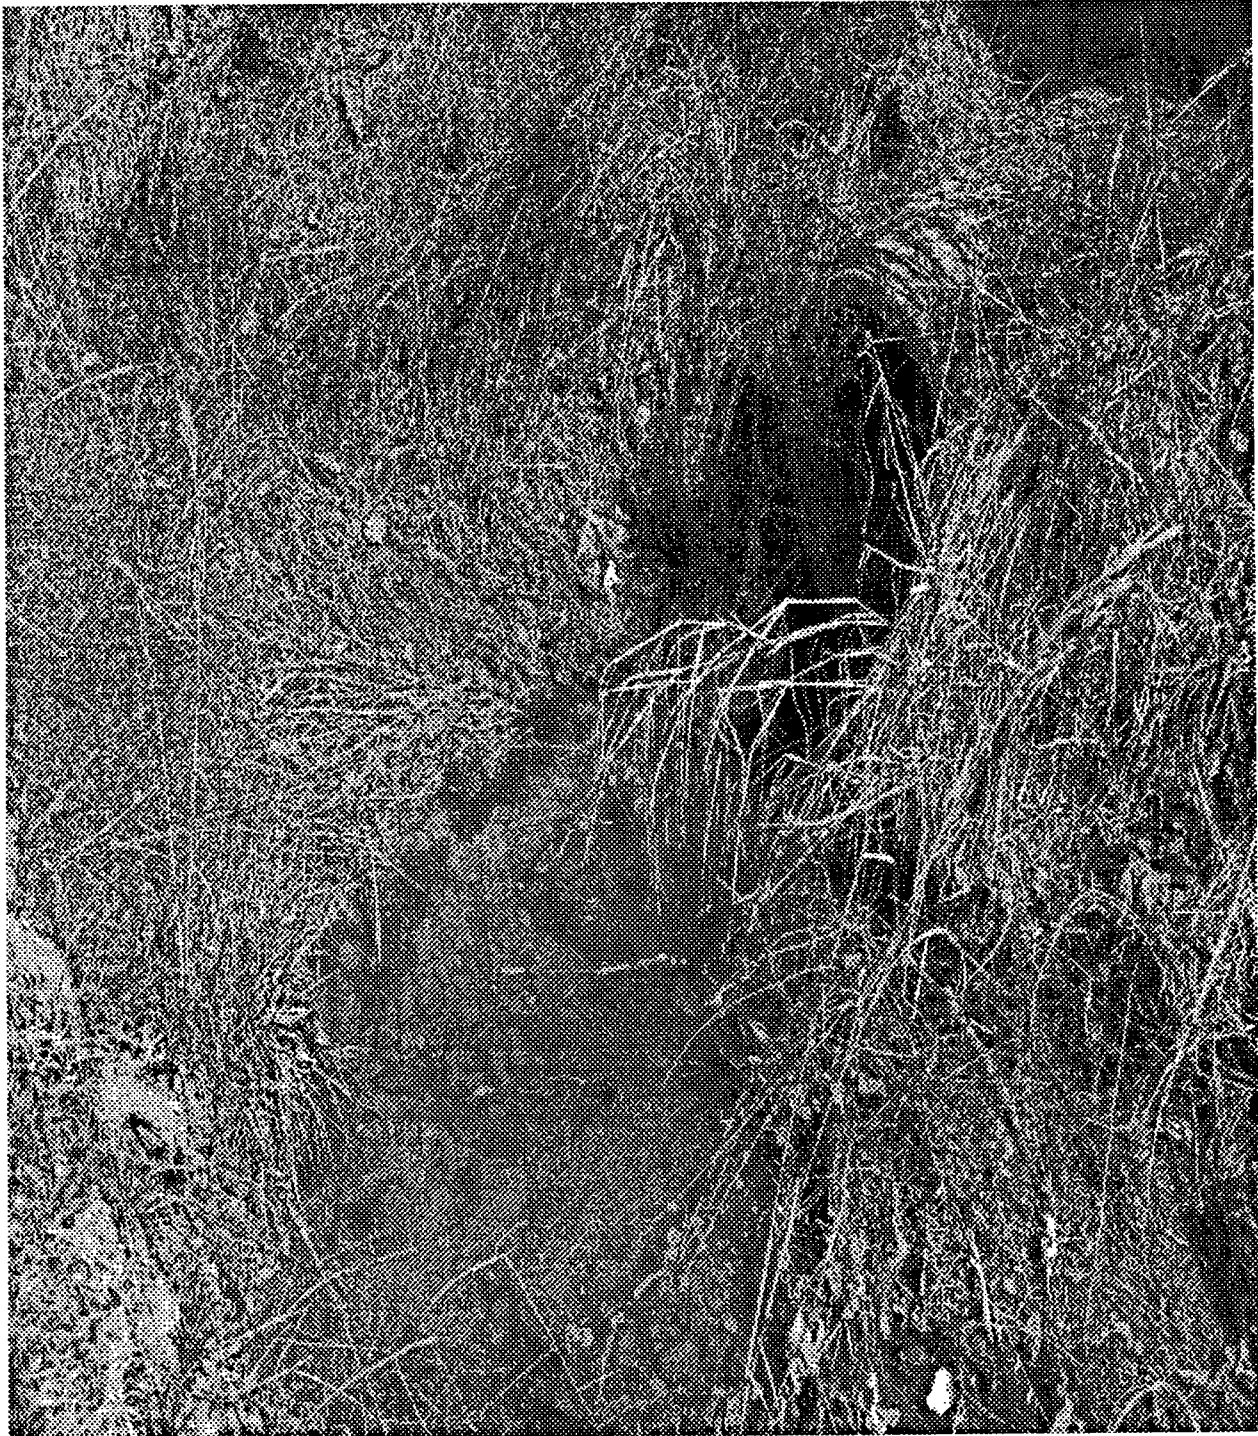
Photo A20 [3/3/98 - 1:14]

Directorate of Engineering and Housing (DEH) compound [CERFA Parcel Map: 17,34-35]

Area consists of Site 64(7) adjacent to N bank of Cane Creek, and contains site 1(7); photo faces E, looking over storm sewer discharge emanating from the western fenceline of the DEH.

The pipe in view may be one of the discharge points for runoff from the DEH compound. Entry points to stormwater drain system, however, may only be found by reviewing utility maps. This particular discharge point empties into the wetland-type area (see Photo A19) and ultimately out to Cane Creek.

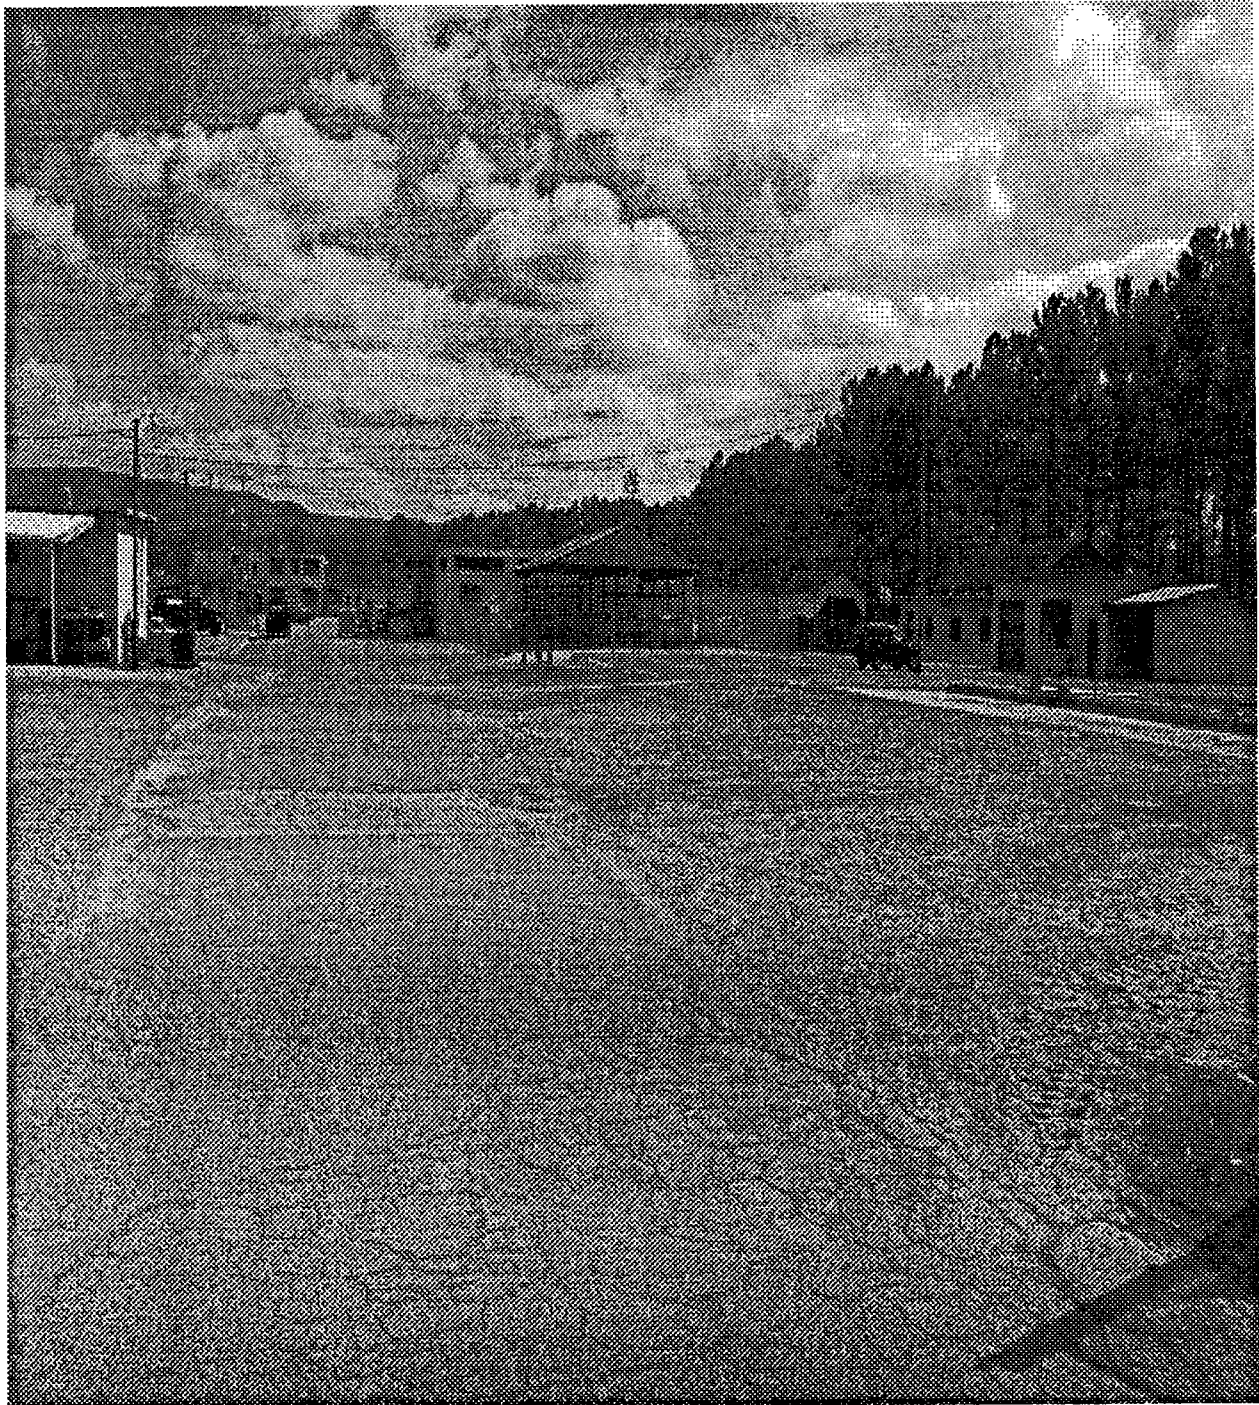
Photo A21 [3/3/98 - 1:15]

Directorate of Engineering and Housing (DEH) compound [CERFA Parcel Map: 17,34-35]

Area consists of Site 64(7) adjacent to N bank of Cane Creek, and contains site 1(7); photo faces S, looking from the western fence gate into the main DEH Area yard.

The area within the fence line is highly developed, industrial terrain. The site is almost completely devoid of any vegetation. Habitat is extremely poor; mice and rats inhabiting buildings and structures may be the only potential receptors. No maintained lawns exist, precluding terrestrial invertebrates, and very little foraging opportunity exists for small birds, as well.

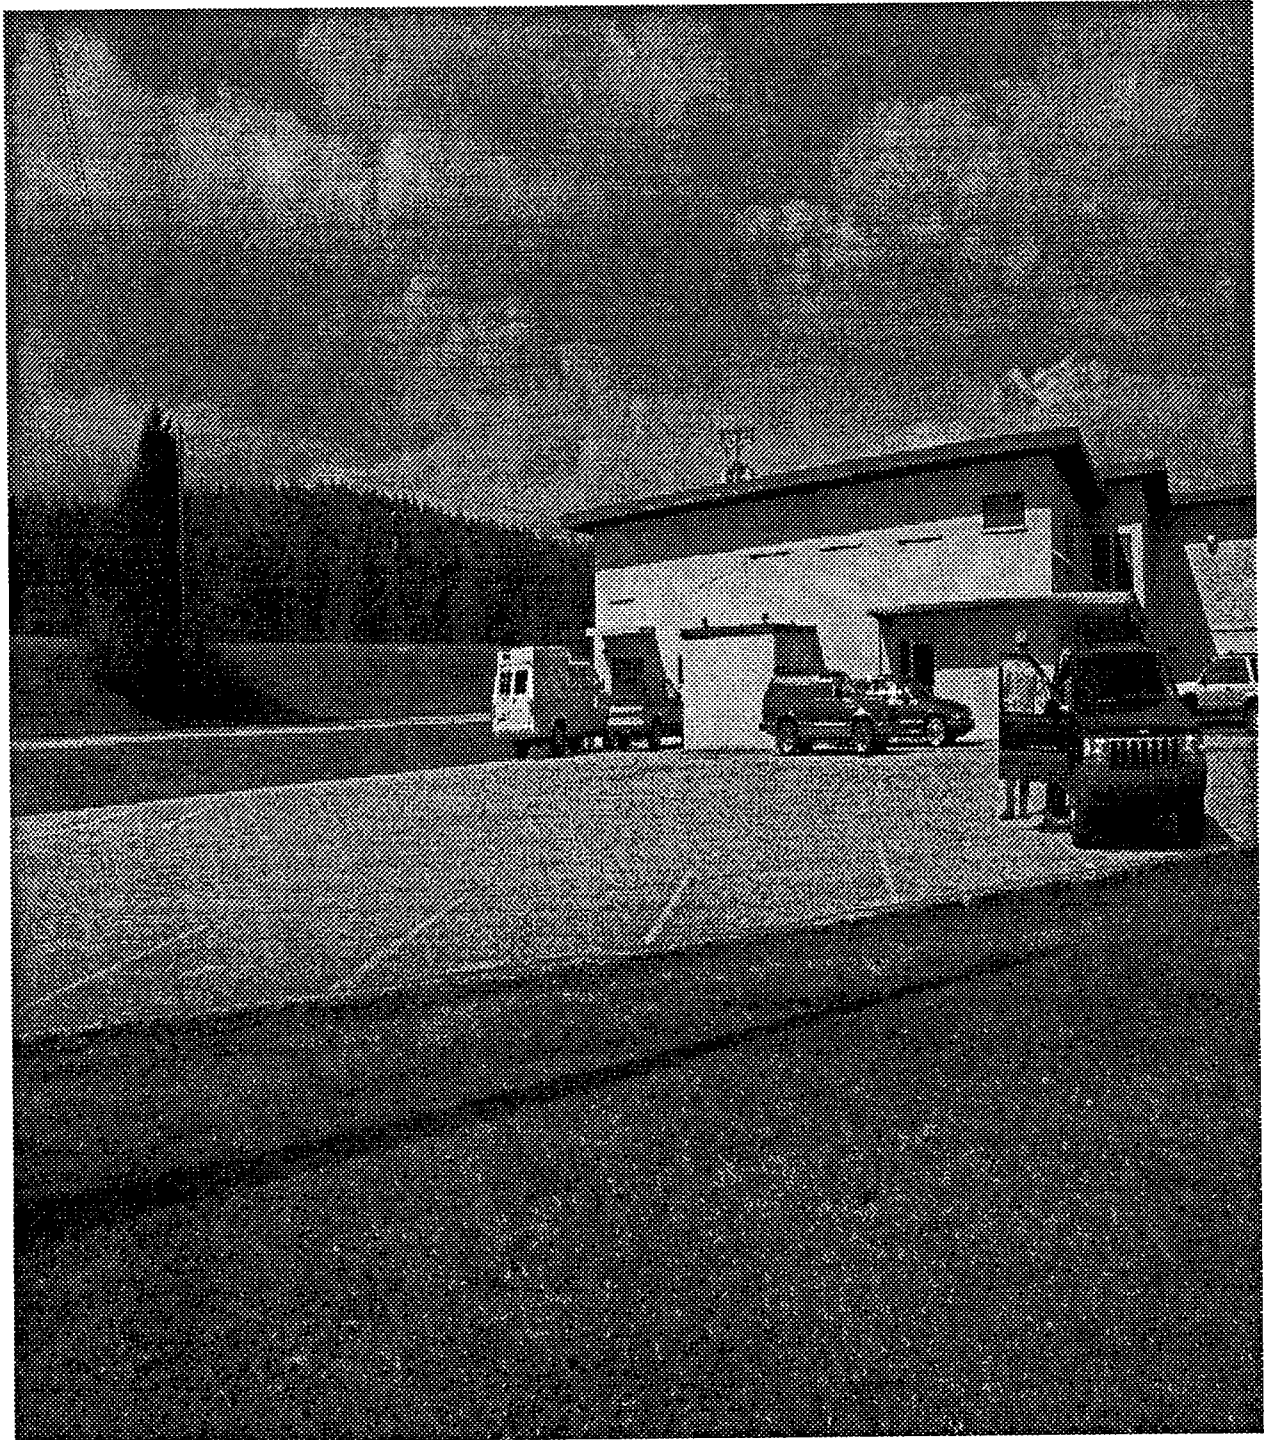
Photo A22 [3/3/98 - 1:35]

Former Training Aids Building (current Service Center Building 267) [CERFA Parcel Map: 20,33-34]
Site 166(7) is a former photography laboratory located in an open area of maintained lawns and roads; photo faces NW direction, looking at the Training Aids Building surrounded by open field and tree stands.

This area is situated in a less developed, open area of the Catonment. To the S is Cane Creek, however, the distance between Site 166(7) and the creek is several hundred yards. Roads and stormwater pipes lie between the building and the creek. The forested area is mainly to the WNW.
